Issues of Enguri Arch Dam Bottom Outlet Structure

Abstract

This report includes some results of dam cantilever strength analysis during operation (chambers service gates water tightness loss).

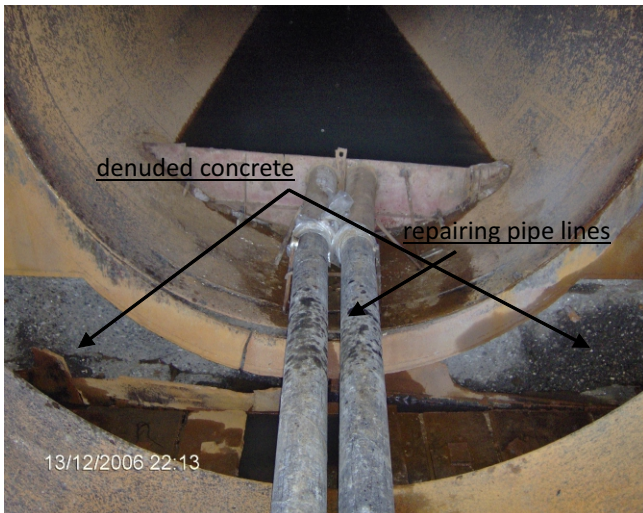
The water loss was $25 \text{ m}^3/\text{s}$ during operation (in 2006, at 500m reservoir level) due to damaged sealing along the most part of the perimeter from upstream face of the maintenance gate. After lowering the service gate (with temporary rubber sealing), the water loss was reduced to $3 \text{ m}^3/\text{s}$. In this moment failure occurred - suddenly water flow increased with accompanying strong noise. Inspection of the service gate chamber revealed (Fig. 5) that:

- the steel plate of the chamber was disconnected from the reinforced concrete and bent by 4.5cm ;
- 2 steel installation plates, which were installed in 1989 during concreting of the bottom part of the chamber were removed from the upstream face of the maintenance gate chamber, and steel surface on the sealing side was very cavitated;
- the rubber sealing of the service gate was also broken (this increased the water flow).

Figure 5. The damaged casing of the chamber of No. 17 outlet maintenance gate

Therefore, the analysis of the inspection results has shown that due to high turbulence of the flow in the maintenance gate chamber, the plates had been broken, which caused disruption of the chamber water tightness and reinforced concrete structure of the cantilever appeared under pressure. The pressure was applied on the service gate chamber, on the chamber casing and concrete contact or through the cracks in the concrete (Fig.6). Finally, the ribbed steel plate was disconnected from the reinforced concrete diaphragm, bent and remained fixed only on perimeter (Fig. 2, 7).

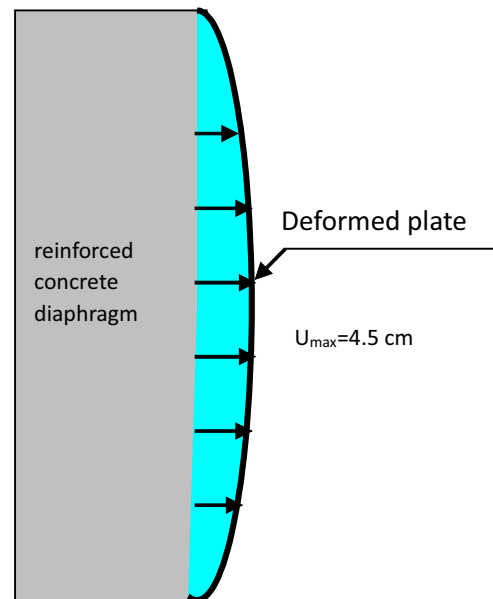
Figure 7. Separation of the metal plate on concrete diaphragm under the influence of seepage pressure

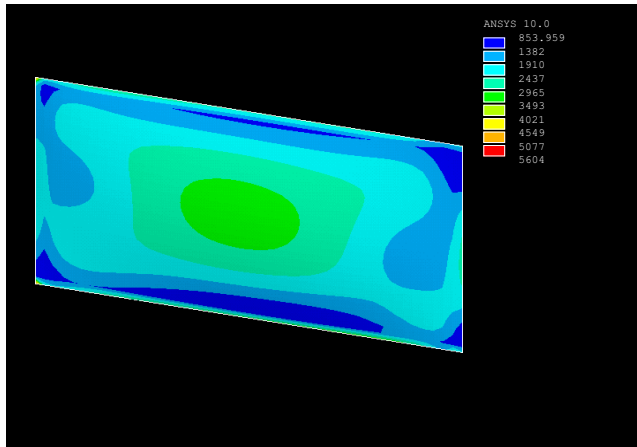
The theoretical calculations of the chamber plates (considering initial 4.5cm value of plate bending) have shown that at 500m reservoir level ($H=170\text{m}$) the load on the steel plate reached 630mN critical value, and the tension stresses of the reinforced diaphragm and plate contact reached $4.5 \times 10^5 \text{ kN/m}^2$ which exceeds the failure limit of the steel. Finally, in the steel plate calculating stresses (by von Mises) at maximum level (510m, $H=181\text{m}$) reached 5604 kN/m² (Fig. 8).

Figure 8 Stress-strain state (by von Mises stress) of the steel plate (service gate chamber).

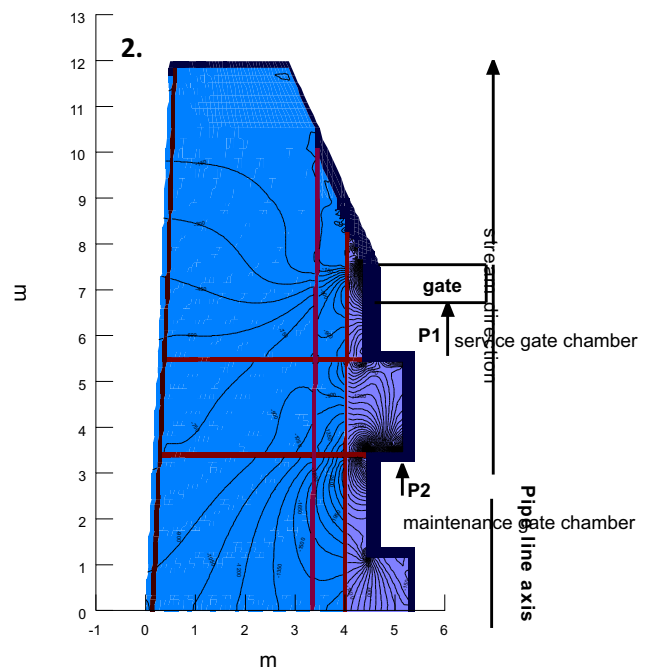
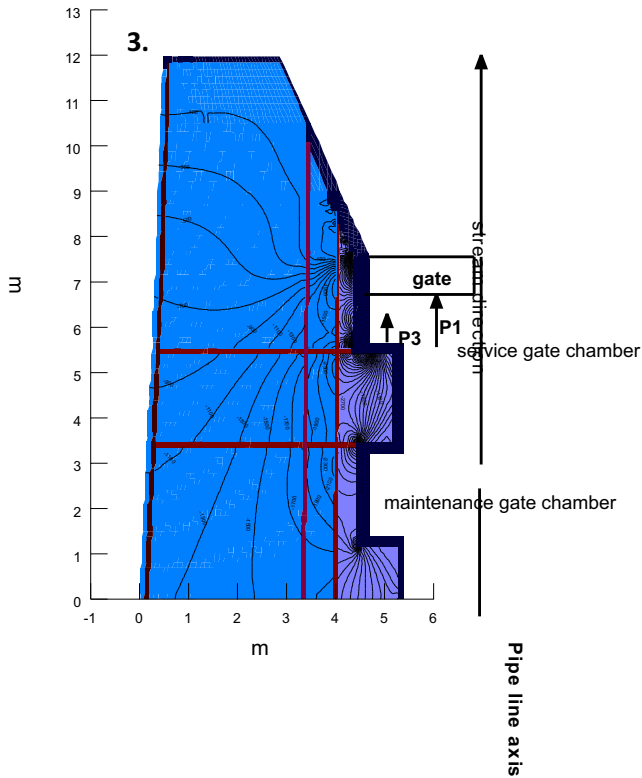
1. In normal operating conditions the maximum tension stress in concrete does not exceed 500 kN/m^2 ;

Figure 9: Tension stresses in cantilever structure (on pipeline axis) with consideration of reinforcement 1., 2., 3. calculation cases

Thus, in 2 and 3 calculation cases the strength margin was considerably reduced (fig. 9) in comparison with normal operating conditions, which makes practical grounds for crack development not permitted by the design. It has to be mentioned that in case of crack development in the concrete of the cantilever structure, the loads are transmitted to the reinforcement, which has high strength margins. However, the risk of developing the pressure in the cracks of the concrete, which increases the loads on the structure, is increased in case of break of gate chamber water tightness.

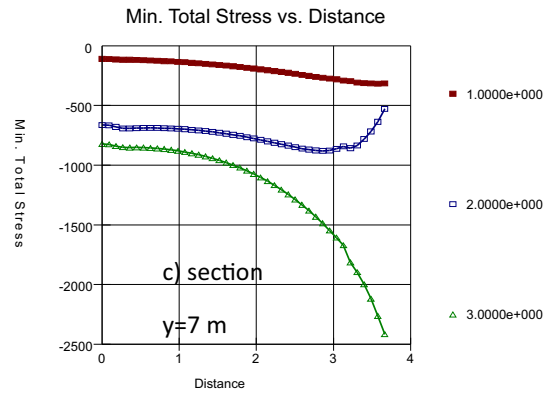
Fig. 10 a), b), c) Tension stresses in cantilever sections for 1., 2., 3. calculation cases.

1. In the condition of pressure influence on the maintenance gate chamber the maximum tension stress is 2400 kN/m²;
 2. In the condition of pressure influence on the service gate chamber from the concrete side the tension stresses are 2450 kN/m² due to increase of stress concentration;
- the maximum stress in the main reinforcement does not exceed 2.1×10^4 kN/m² (Fig. 12).

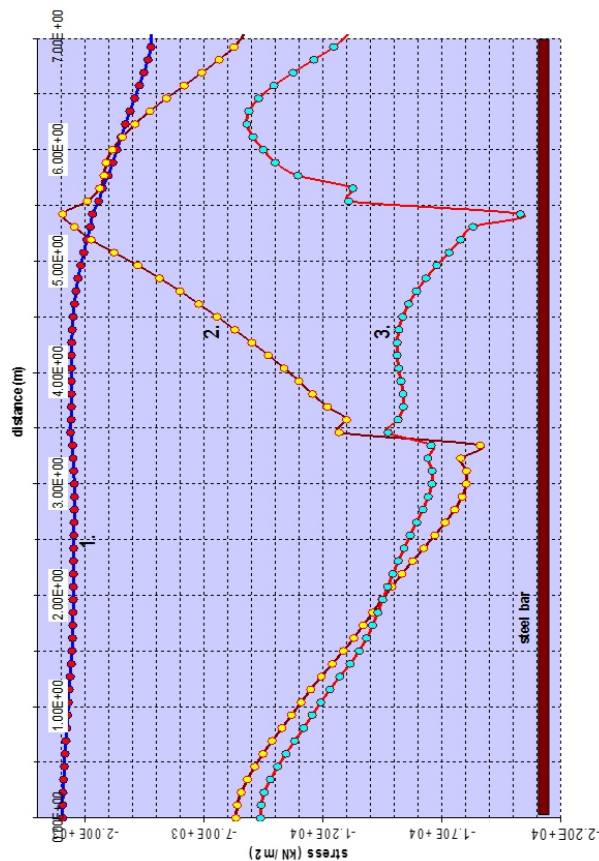
Figure 12. Tension stresses in main reinforcement for 1., 2., 3. calculation cases

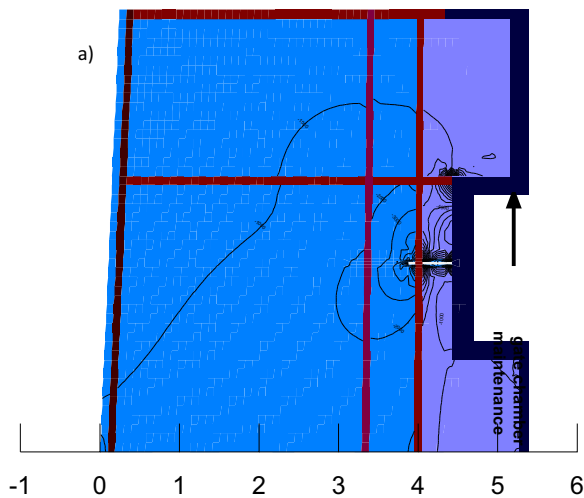
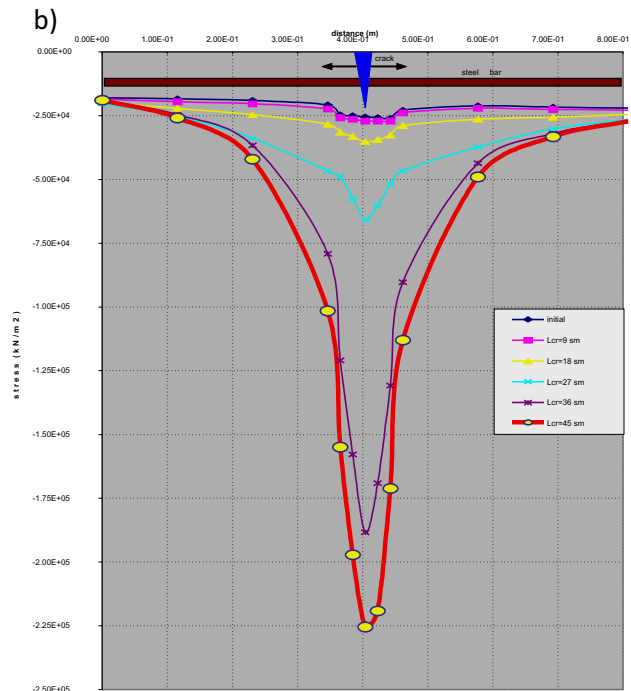
Fig. 13 Tension stresses propagation in the vicinity of cracks: a) in the cantilever structure with critical length (Lcr=45cm) crack; b) in the main reinforcement with gradual increase of crack length.

On the basis of fracture mechanics it was defined that when operation loads are applied, the condition for crack development $K_I > K_{IC}$ (where K_I , K_{IC} are design and critical values of stress intensity factors respectively) is fulfilled in the crack existing in the concrete. Thus, in case of crack development in cantilever structure, the strength depends only on the bearing capacity of steel reinforcement.

The iterations have been carried out, which considered the crack with increased length ($cmL5=\Delta$). It was defined that the crack with $L_{cr}=45cm$ is critical and at this time the tension stresses reach the design tension strength of steel [$R=2.7 \times 10^5 kN/m^2$ (fig. 4.2.1)].

Considering the inspection results and inability to install the seal between the maintenance gates and chambers, it is necessary to concrete the lower parts of the chambers of the remaining outlets in order to ensure safety of the dam. In

· addition, the water tightness of the chamber should be ensured.
