Issues of Enguri Arch Dam Bottom Outlet Structure

Abstract

This report includes some results of dam cantilever strength analysis during operation (chambers service gates water tightness loss).

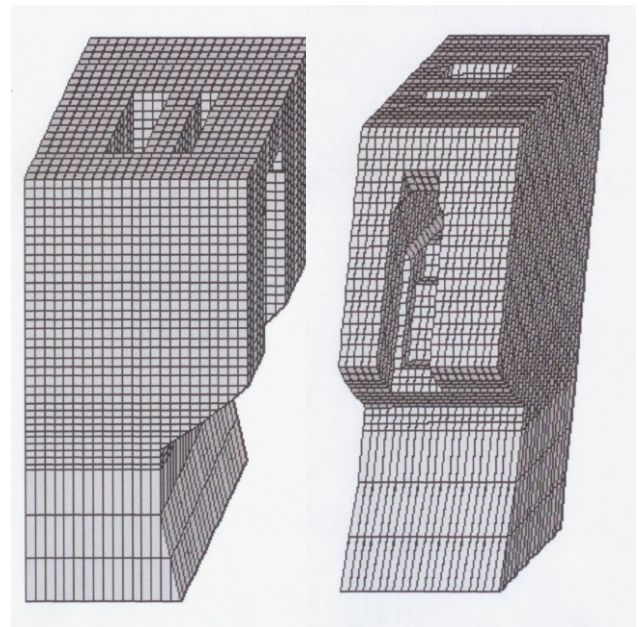
The failure and abnormal operation conditions of N17 outlet necessitated an assessment of stressed condition and strength margin of the cantilever. For this purpose the structure was calculated within the 3D model of elasticity theory, using the isoperimetric elements (fig. 4) (Bathe, 1976).

Figure 4 Calculation scheme of cantilever part of N17 outlet. The main bearing steel bars of the cantilever was considered according to the specific parameters (elasticity modulus and stress):

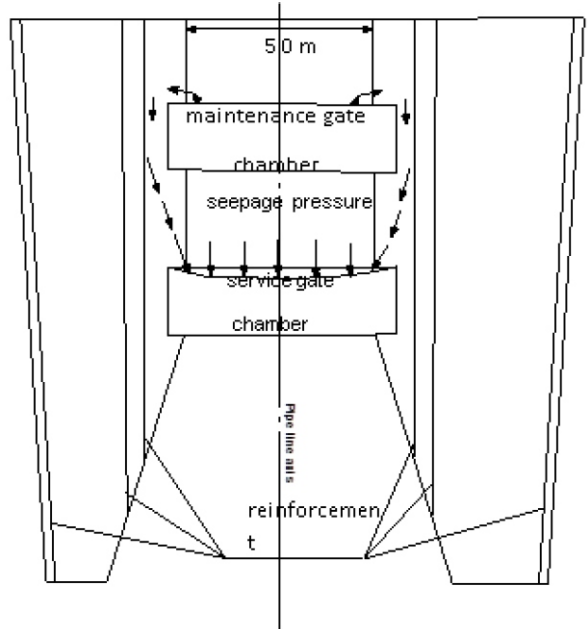
Figure 6 Bottom outlet section

Therefore, the analysis of the inspection results has shown that due to high turbulence of the flow in the maintenance gate chamber, the plates had been broken, which caused disruption of the chamber water tightness and reinforced concrete structure of the cantilever appeared under pressure. The pressure was applied on the service gate chamber, on the chamber casing and concrete contact or through the cracks in the concrete (Fig.6). Finally, the ribbed steel plate was disconnected from the reinforced concrete diaphragm, bent and remained fixed only on perimeter (Fig. 2, 7).

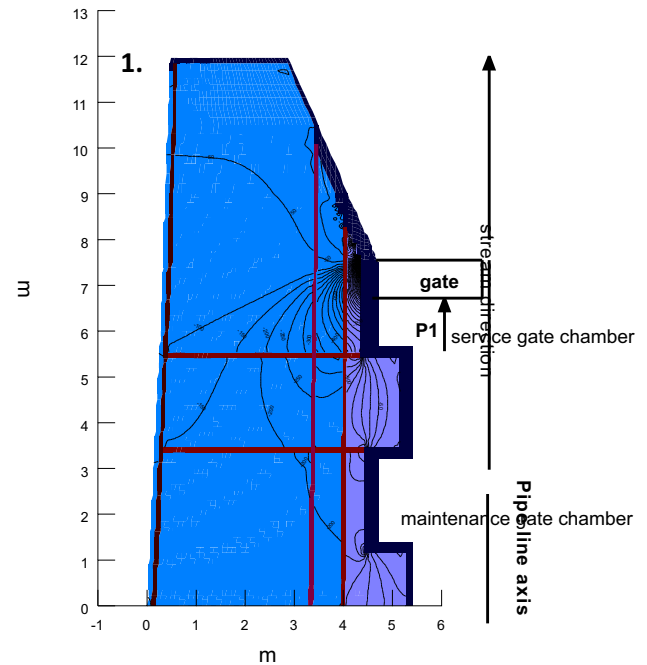
The theoretical calculations of the chamber plates (considering initial 4.5cm value of plate bending) have shown that at 500m reservoir level ($H=170\text{m}$) the load on the steel plate reached 630mN critical value, and the tension stresses of the reinforced diaphragm and plate contact reached $4.5 \times 10^5 \text{ kN/m}^2$ which exceeds the failure limit of the steel. Finally, in the steel plate calculating stresses (by von Mises) at maximum level (510m, $H=181\text{m}$) reached 5604 kN/m² (Fig. 8).
